National Transportation Safety Board

Railroad Accident Brief

Derailment of WMATA Metrorail Train in Interlocking Falls Church, Virginia

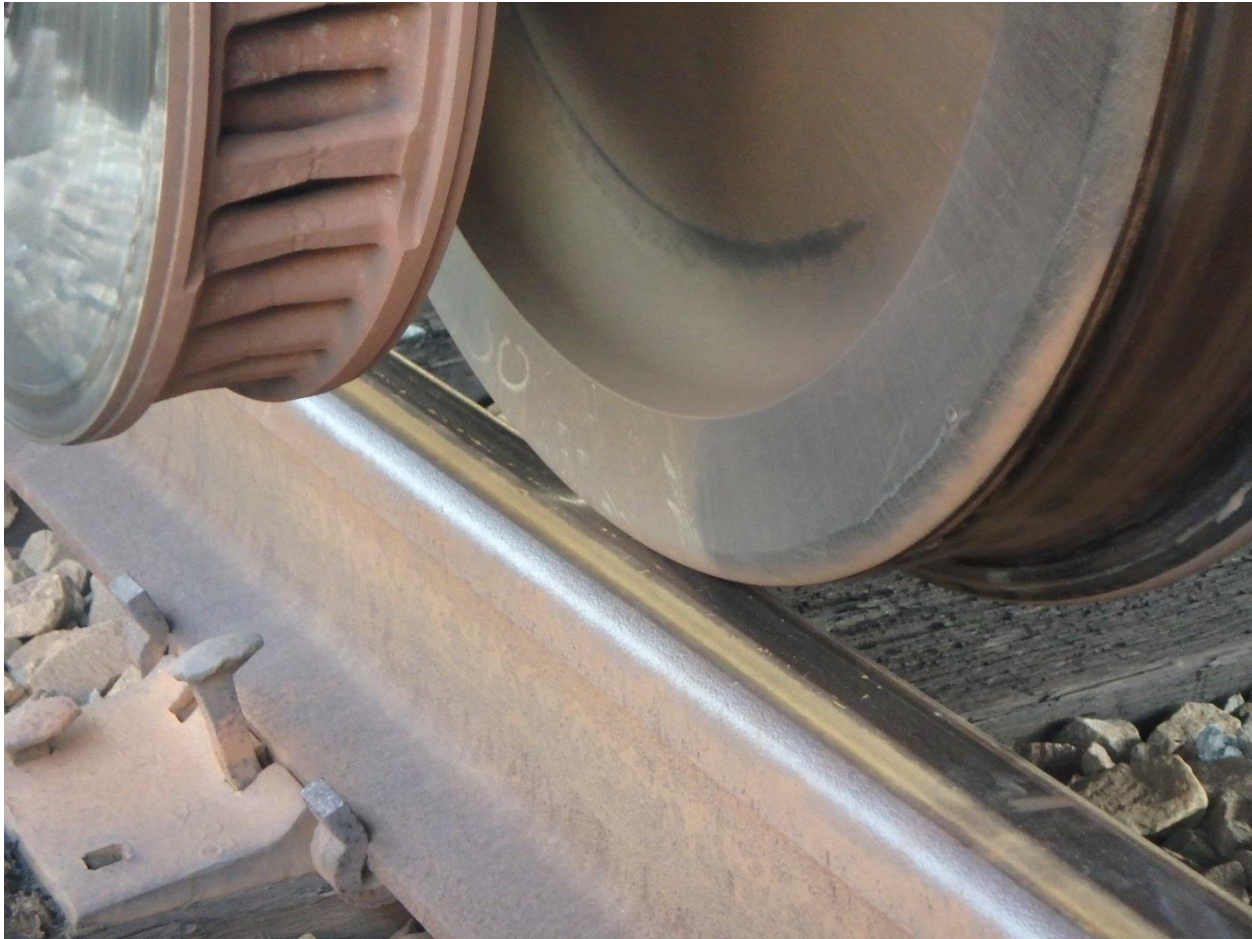
measurement of 59 inches.⁸ When track gage is too wide, the proper wheel-rail interface cannot be maintained and derailment is likely. (See figure 1.)

Figure 1. Equipment wheel misalignment and rail head discoloration.

The area where the train derailed should have been easily identified by WMATA and FTA as an area of concern because discoloration on the running surface of the north rail was visible, indicating that the wheels of the passenger vehicles were not properly aligned with the running rails. (See figures 1 and 2.)

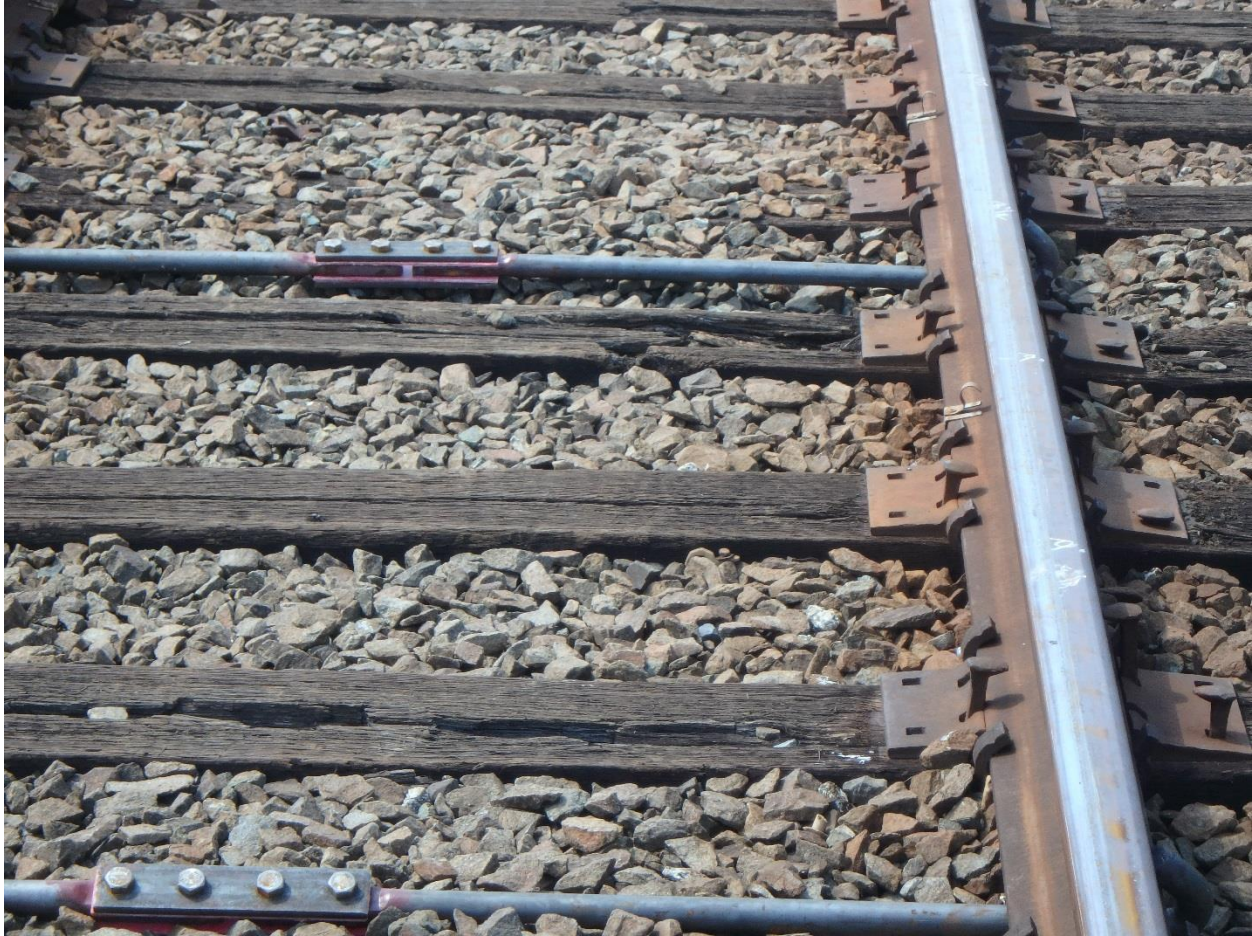
There were 18 crossties in 40 feet of track near the POD. Of those, 16 were not in compliance with WMATA standards or FRA track safety standards, resulting in about 400 inches of unsupported rail. The deteriorated crosstie condition allowed for a total dynamic track gage

Figure 2. Deteriorated cross-ties at accident location. The gage rods were added postaccident.

Also, the lateral movement of the tie plate in relation to the cross-tie was noted throughout the derailment area. Investigators observed a static track gage measurement of 58-1/4 inches, with an additional lateral movement of 3/4 inch, totaling 59 inches of dynamic track gage.⁹
